*Abstract*

## Vibration damage levels for museum objects

**David Thickett**

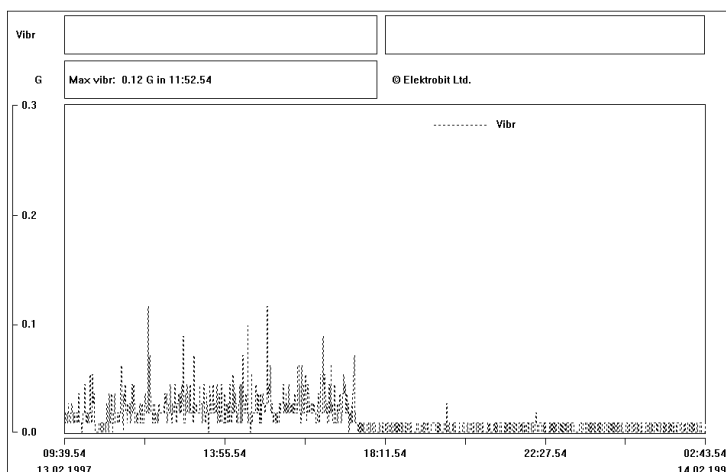
A survey of vibration levels around the museum's galleries induced by day-to-day activities, such as visitor circulation, yielded average accelerations of between 0.006 g and 0.15 g and emphasized the extremely localized nature of some vibrations. A typical chart of the vibrations experienced in a wooden-floored, upper storey gallery is shown in Figure 1. The distinctive high acceleration spikes were observed in almost all of the measurements.

Figure 1. Typical graph of vibration in a wooden floored gallery

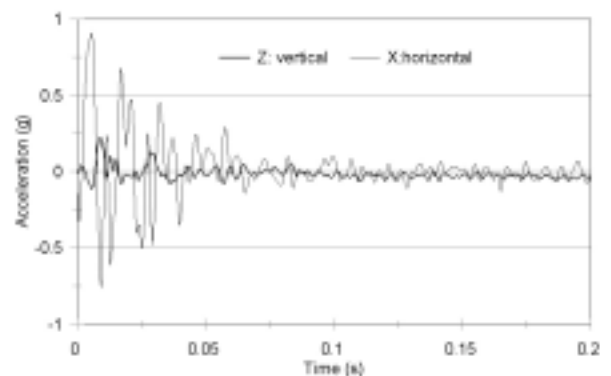
This was further investigated using the shocklog data-logger. Figure 2 shows two components of the vibration. As can be seen, the high acceleration peaks begin in the horizontal (x) direction and only afterwards are detected in the vertical direction. This is consistent with visitors banging against showcases.

Figure 2. Components of typical shock event in a showcase

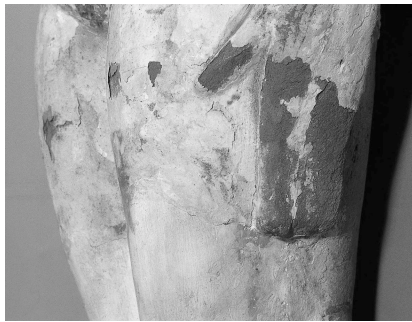
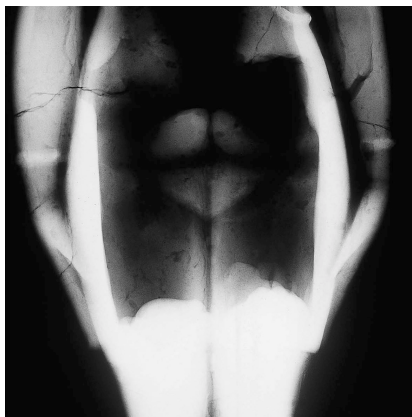
Figure 5. Loss of material from terracotta figure localized in band around top of thigh

Figure 6. Radiograph showing coincidence of extent of plaster fill

Damage on two terracotta anthropoid figures was concentrated in a band running around the thighs. Radiography showed that this corresponded to the edge of plaster fills inside the legs (see Figures 5 and 6). Initially, soluble salts introduced from the plaster were suspected as the cause of the weakening. However, analysis showed this assumption to be false and the weakening was ascribed to the action of water and the penetration and subsequent hydration of plaster through the unsealed terracotta break surface. The weakened paint layers and terracotta were damaged by vibration levels of 0.5 g, caused by the storage of metal I beams directly adjacent to the showcase containing the two figures.

Temporary storage of building materials also needs to be considered. The two terracotta figures of Aphrodite-Isis were damaged from shock generated by the repeated dropping of metal I beams beside their case.

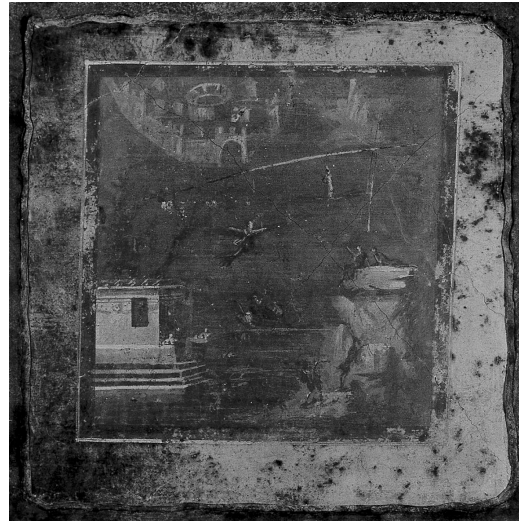
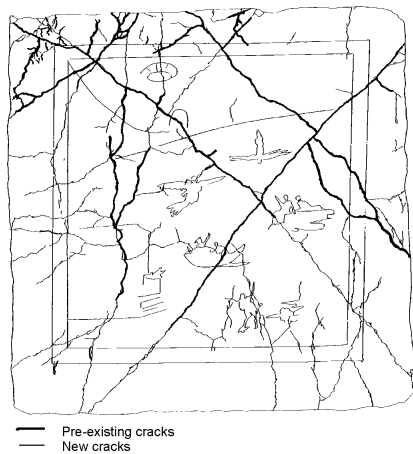
Figure 4. Schematic of cracking in 1991 and after building work vibration

Figure 3. Roman wall-painting depicting the death of Icarus

The majority of damage had occurred in areas of existing weakness within the objects. Damage to the *Death of Icarus* wall painting was manifested as an opening up and extension of existing cracks (see Figures 3 and 4). Several new cracks had also been initiated in the plaster. The vibration originated from work being undertaken at the base of the wall on which the wall painting was mounted and its magnitude was between 0.2 g and 0.4 g when loss was observed.
